# Indore Walkability Study

*Indore, India*

*EMBARQ*

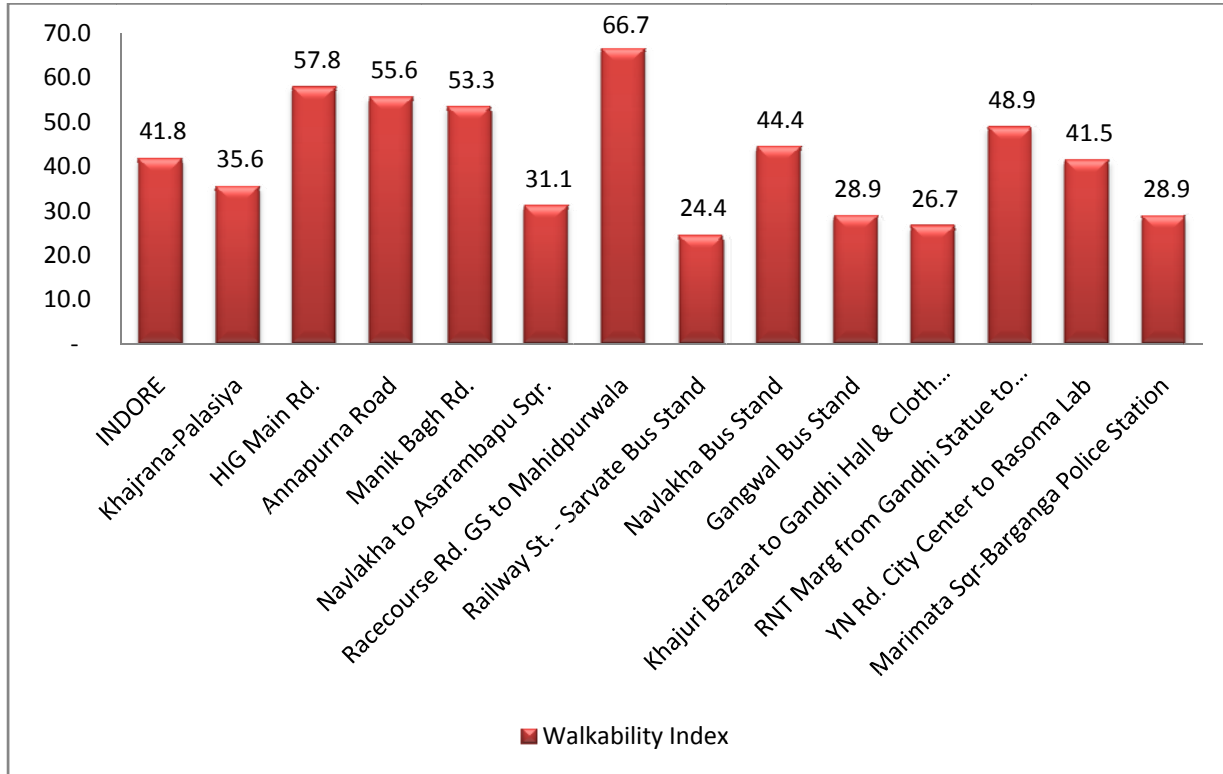
- The walkability index of the Indore city is coming out to be 41.8.
- Racecourse road has a high walkability index of 66.67 as the quality of infrastructure is better than other areas.
- The availability of sidewalks and if they are available then there is permanent or temporary encroachment and its access to disabled people is the biggest barrier in improving walkability. Also the availability of proper crossing is the other concern. It comes out during the survey that there are few crossings available in the city and are not considered safe.
- There was no observed consistency in design (width, height, continuity) of footpath and road crossing.

Walkability Index score for Indore and other surveyed areas.

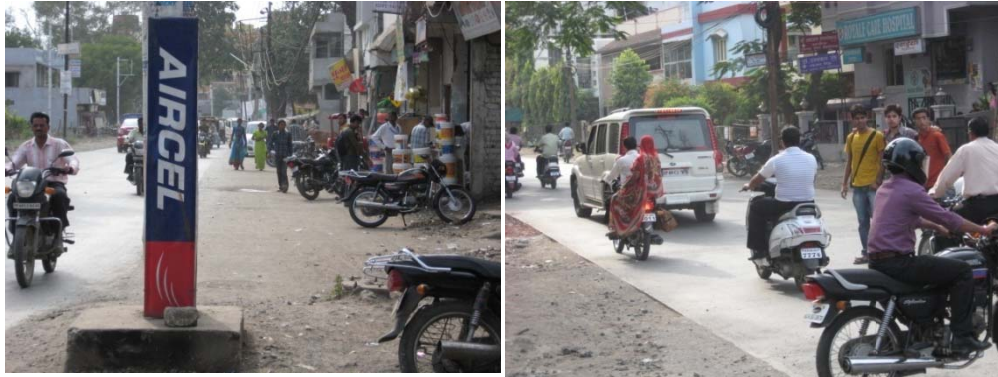
## Khajrana-Palasiya

1. No walkway at the section, available space can be used for better maneuver of pedestrians by constructing new walkway.
2. No facilities for crossing, speed humps at the crossing and zebra crossing can improve the safety for pedestrians

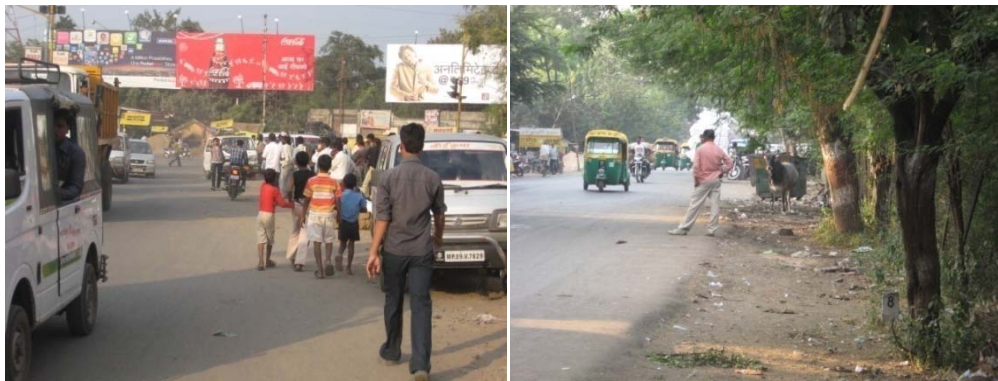
## Navlakha to Asarambapu

1. Public van and other vehicles are parked on the space available for walkway, unmountable walkway can solve the problem and protect pedestrians to walk between the vehicles.
2. Dumpster and animals on the temporary sidewalk making it difficult for pedestrian to use it.

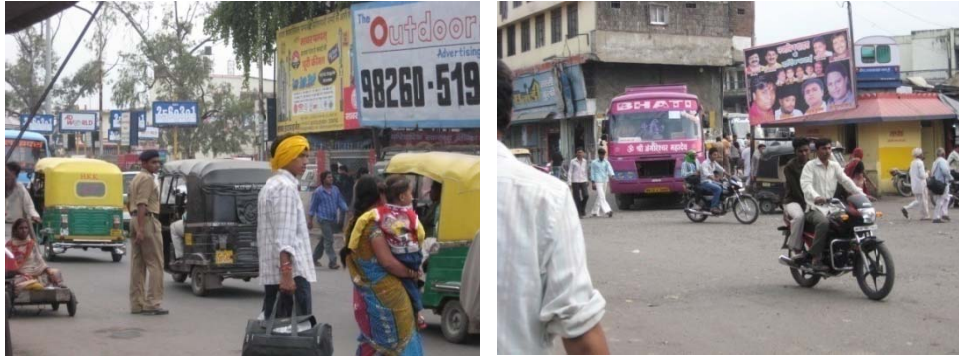
## Railway Station to Sarvate Bus Stand

No pedestrian facility at the busiest transport terminal in the city, a foot over bridge or a subway make it easy for pedestrian to cross.

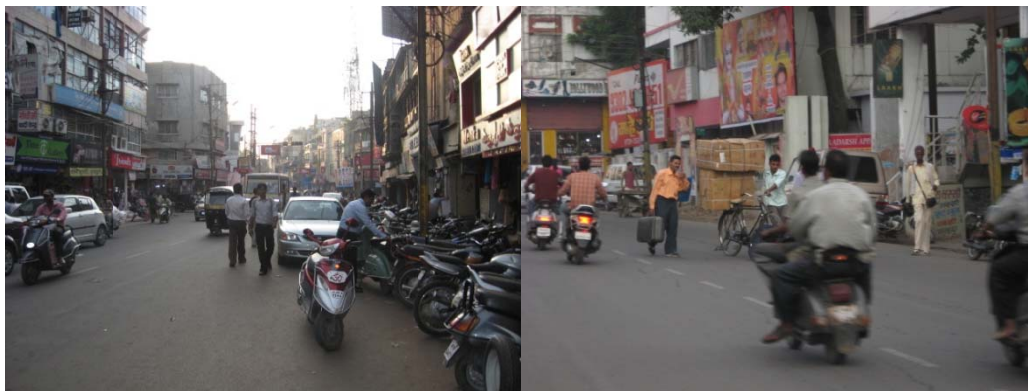
## Khajuri Bazaar to Gandhi Hall

1. Sidewalks are completely occupied by two wheeler parking pedestrians are walking on the road between the vehicles. This can be controlled by law and enforcement.
2. No crosswalks on the road make it difficult for pedestrians to cross. Raised crosswalks can slower the traffic at this busy road and make it more pedestrian friendly.

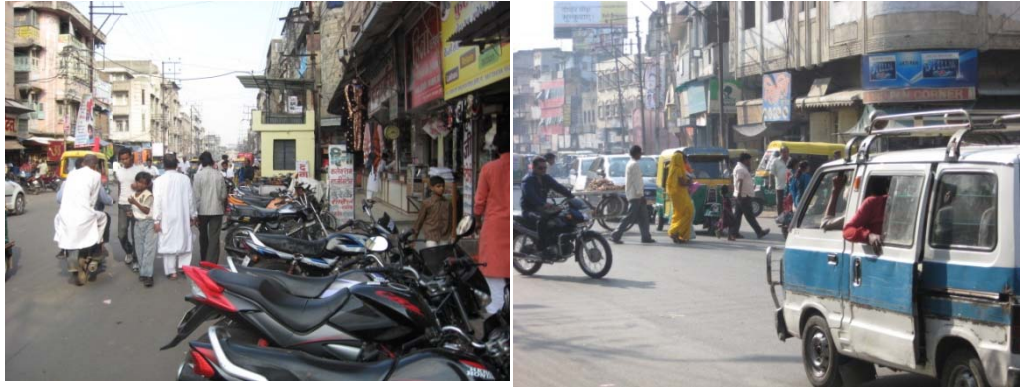
## Cloth Market to Patel Bridge

Parked two wheeler and a police booth on the walkway left no space for pedestrian to walk on it. Being a most commercialized area of the city should be made no vehicle zone for safe maneuver of pedestrian.

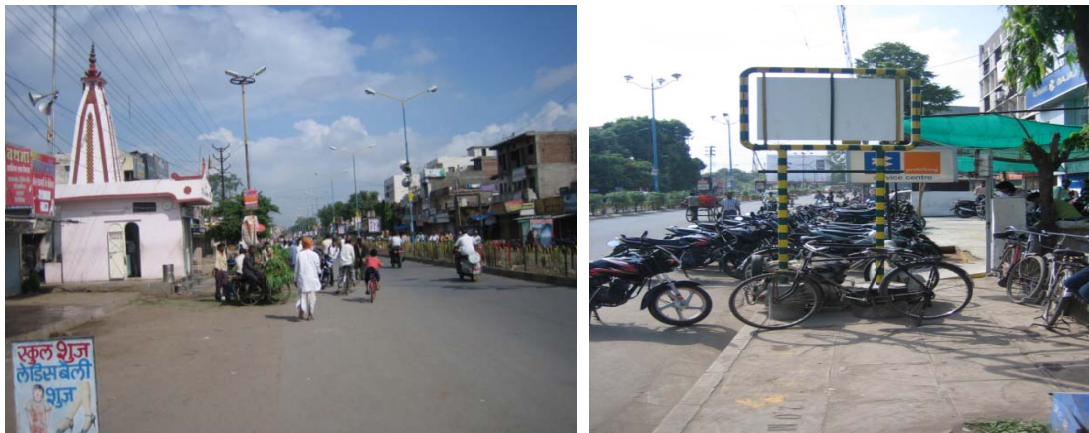
## HIG Main Rd.

1. At this temple the carriageway narrows to only 2 lanes. Despite the narrowing, no bottlenecks in vehicle traffic are observed, demonstrating that the traffic volume can be accommodated with just 2 lanes.
2. This speed limit sign blocks nearly the full footpath; it could easily be redesigned with a single support to be unobstructive.

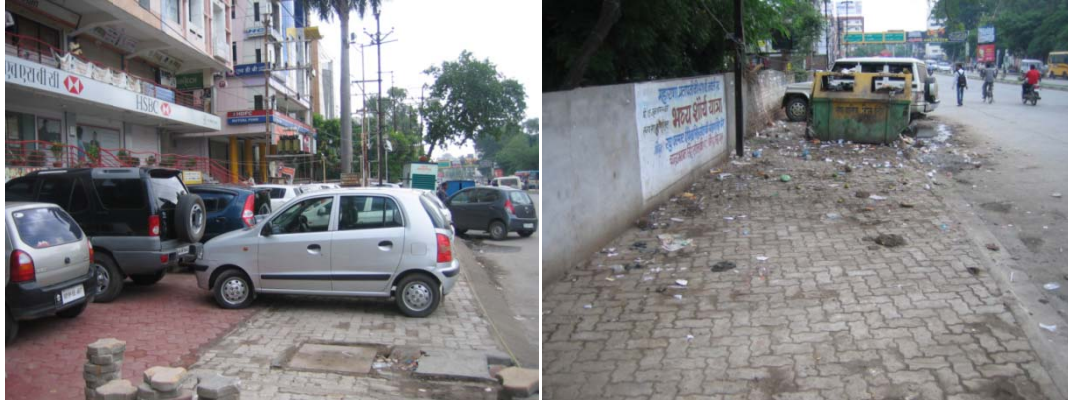
## Racecourse Rd. GS to Mahidpurwala

1. Parking lot spillout completely blocks footpath.
2. Dumpsters kept in footpath obstruct the footpath and lead to litter and smells.

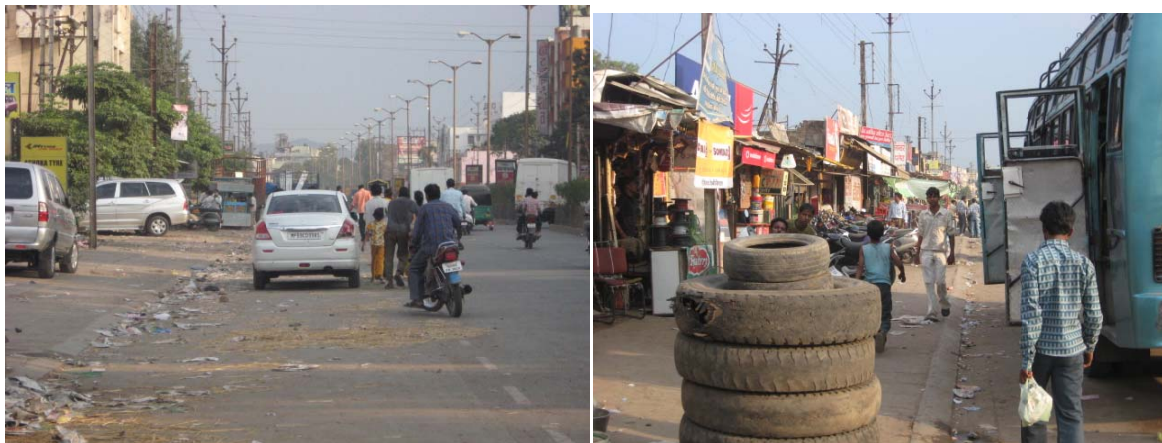
## Navlakha Bus Stand Agrasen Statue

Available sidewalk is very untidy discourages people to walk on it and also roadside vendors occupied the walkway break its continuity.

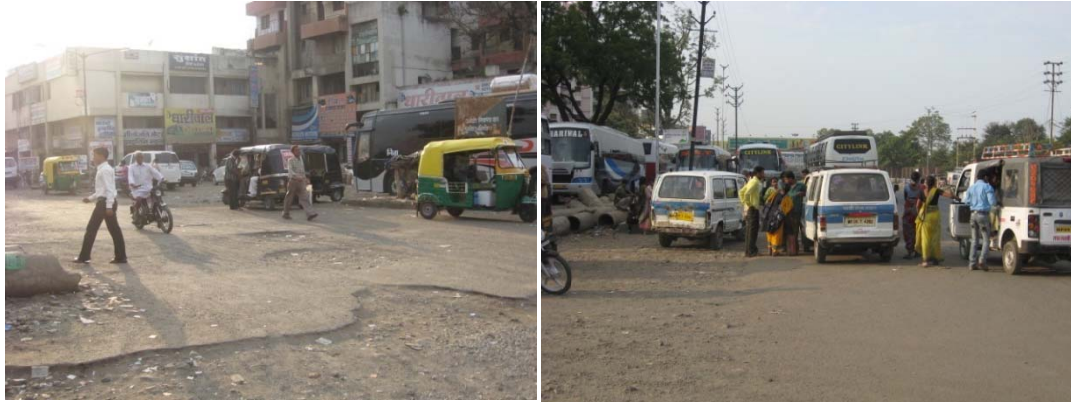
## Navlakha Bus Stand AB Rd.

No boarding alighting facility for the passengers coming to Bus Stand by public van or rickshaw they have to board or alight on the road only.

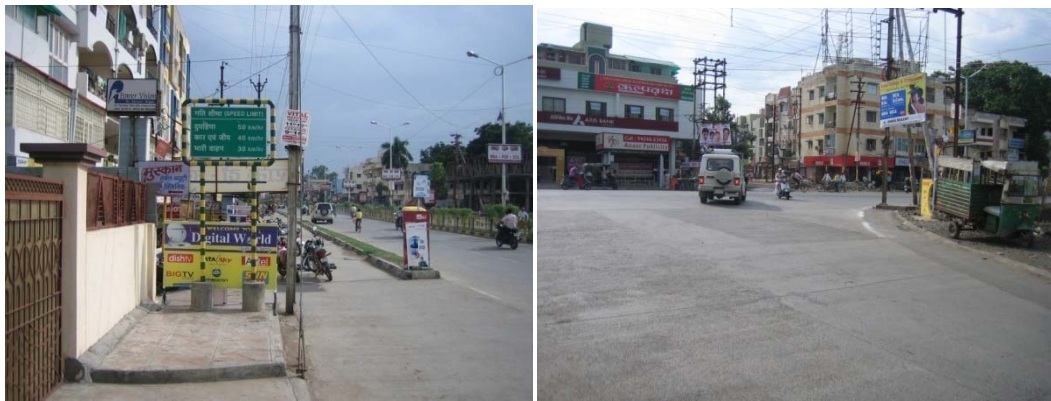
## Annapurna Road

1. This sign completely blocks the footpath. The second pole and central placement are unnecessary.
2. This wide curb radius means a longer distance for pedestrians to cross, and means they are more at the periphery of drivers' field of vision.

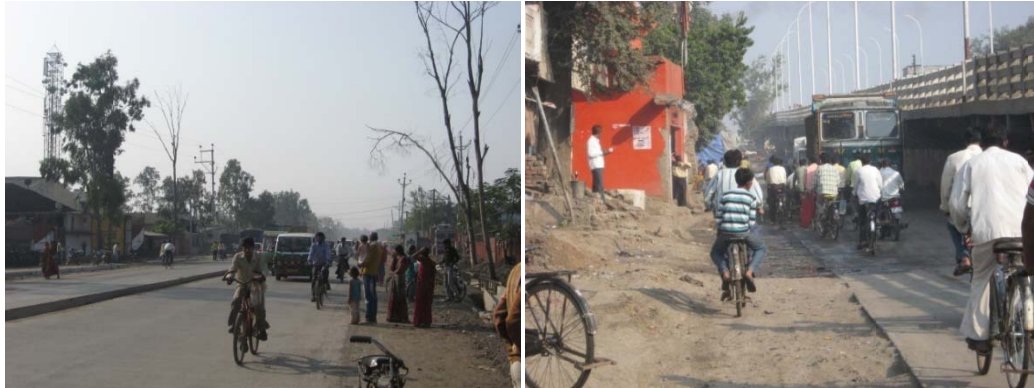
## Marimata Square to Barganga Police Station.

Being an industrial area, high number of pedestrian and cyclist are there but no supporting infrastructure is available. Addition of a NMV lane will helps the user.

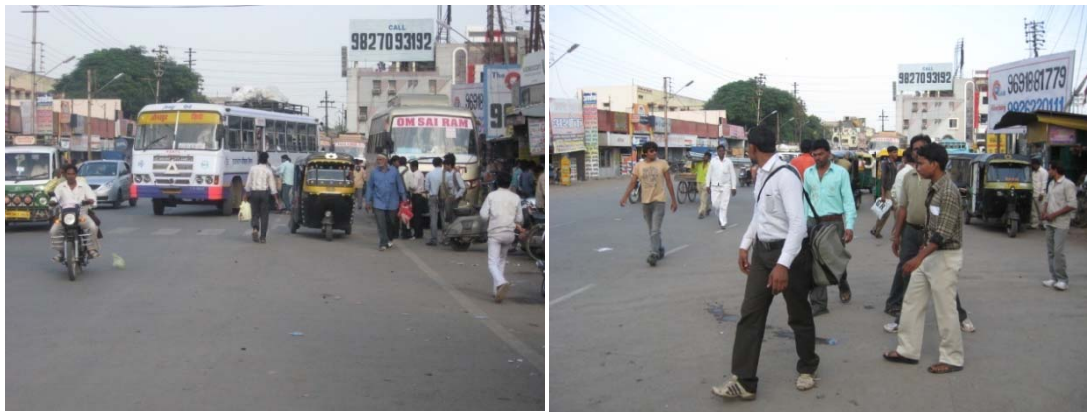
## Gangwal Bus Stand

Another busy transport terminal of the city no sidewalks are present. Buses and the other vehicles are parked on the portion of the road marked for pedestrians. Unmountable sidewalks and subways should be constructed.

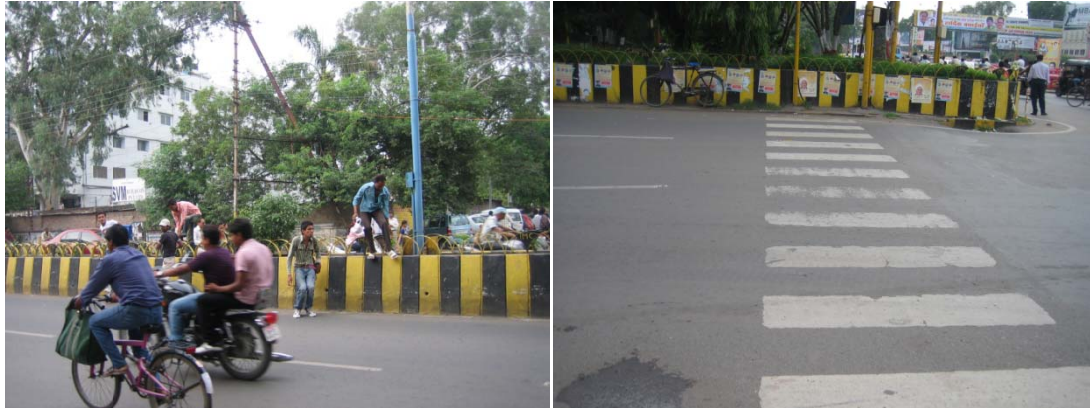
## RNT Marg from Gandhi Statue to Nehru Statue

1. There is no crossing opportunity near the Center Mall, despite the fact that many people want to cross here.
2. Median provides no crossing assistance. Improperly aligned with crosswalk and no space for pedestrians to walk.

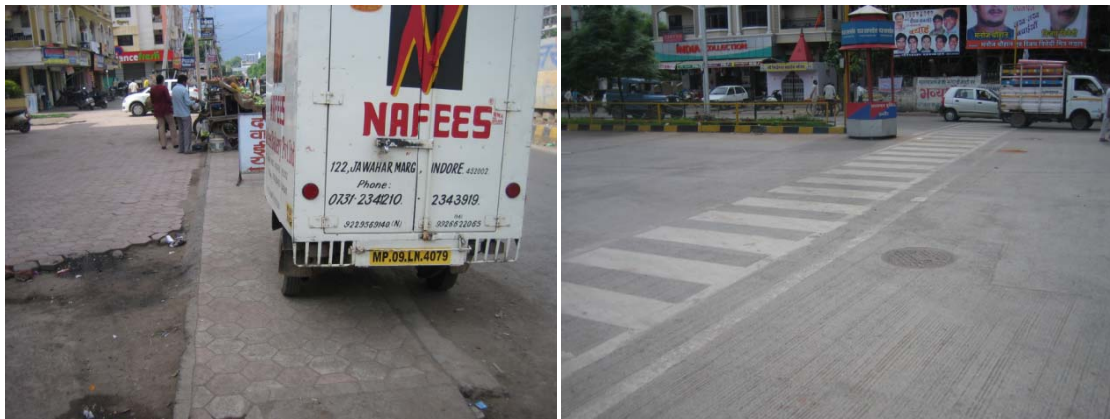
## Manik Bagh Rd.

1. Mountable curbs invite parking obstruction.
2. The distance to be crossed at Palsikar Junction is quite long. The median provides little refuge and the crosswalk is encroached upon by queued vehicles.

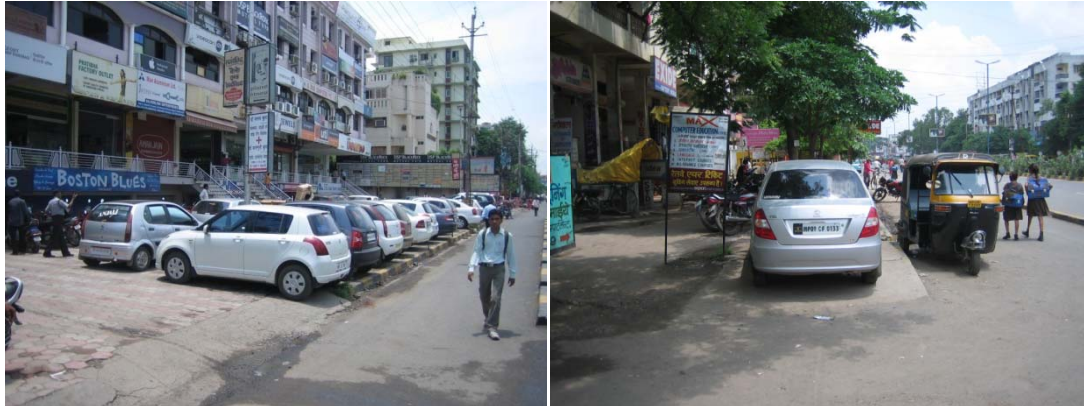
## YN Rd. City Center to Malwa Mill Square

1. Parked vehicles are perhaps the most egregious obstruction in this corridor. Here, the shopping center's lot has taken over the footpath. Ways to move parked vehicles to the curb, where excess carriageway space could be devoted to parking, should be explored. This space holds great potential for benches or other pedestrian amenities
2. Bollards could prevent vehicles from parking on this curb, without eliminating the ramp.

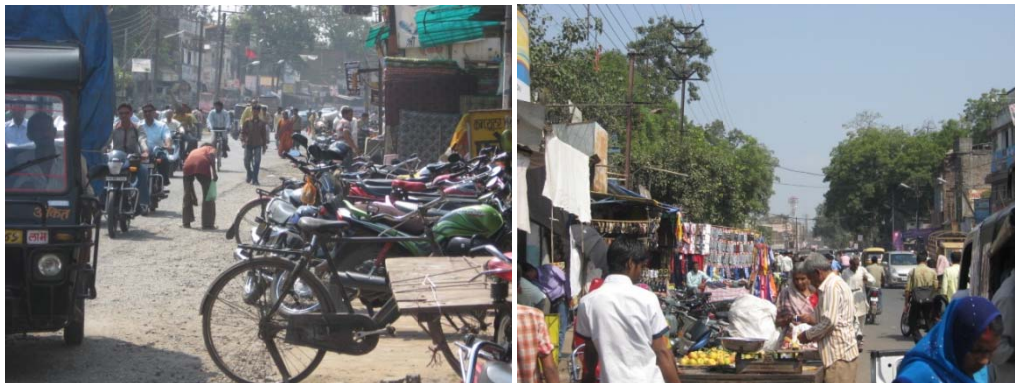
## Malwa Mill Square to Patnipura

This area is surrounded by the low income group people. Lot of activity on the street but no separated walkways are there.

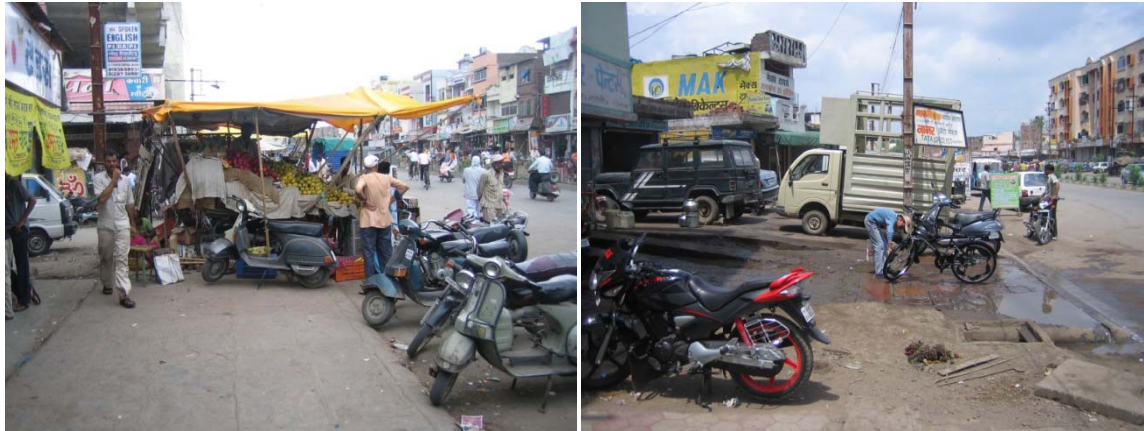
## Patnipura to Rasoma Lab

1. Fruit and vegetable vendors interfere with movement on the northbound side near Patni Puri Jn. This appears to be one of the city's major vegetable markets and is heavily patronized. The vendors likely value the high level of exposure from this heavily traveled road.
2. Industrial spillout obstructs and soils the footpath.
