Full Length Research Paper

Heavy metal contamination of groundwater resources in a Nigerian urban settlement

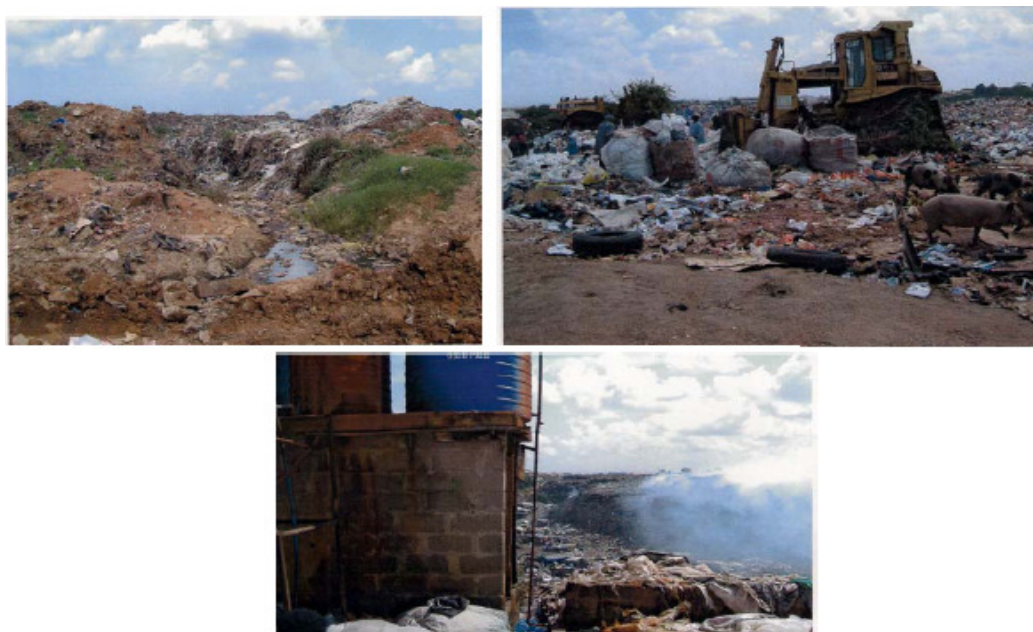
Figure 2. Some perspectives of Olusosun landfill (dumpsite) in Ojota area, Lagos, as at October, 2007.

The study was carried out in Ojota area of Lagos State in Nigeria. The area covers Ikosi Ketu, Oregun industrial estates, the commercial area of Kudirat Abiola way, Ojota residential area and LAWMA dumpsite (Figure 1), known as Olusosun landfill (Bello, 2002). The landfill is located between 6°23'N; 2°42'E and 6°41'N; 3°42'E. It is the largest of all the landfills in Lagos area; it has received more than 50% of the total refuse in Lagos area since 1989. As at the period when the dumpsite was created, the area (Ojota) was almost a vacant land (Bello, 2002). The area is however a flourishing commercial central district in Lagos State. Figure 2 shows some views of the landfill as at 2007.
